# **CH-47**

## CH-47 ACCIDENT SUMMARY

1 July 1966 through 30 June 1967

by  
P. R. Thompson

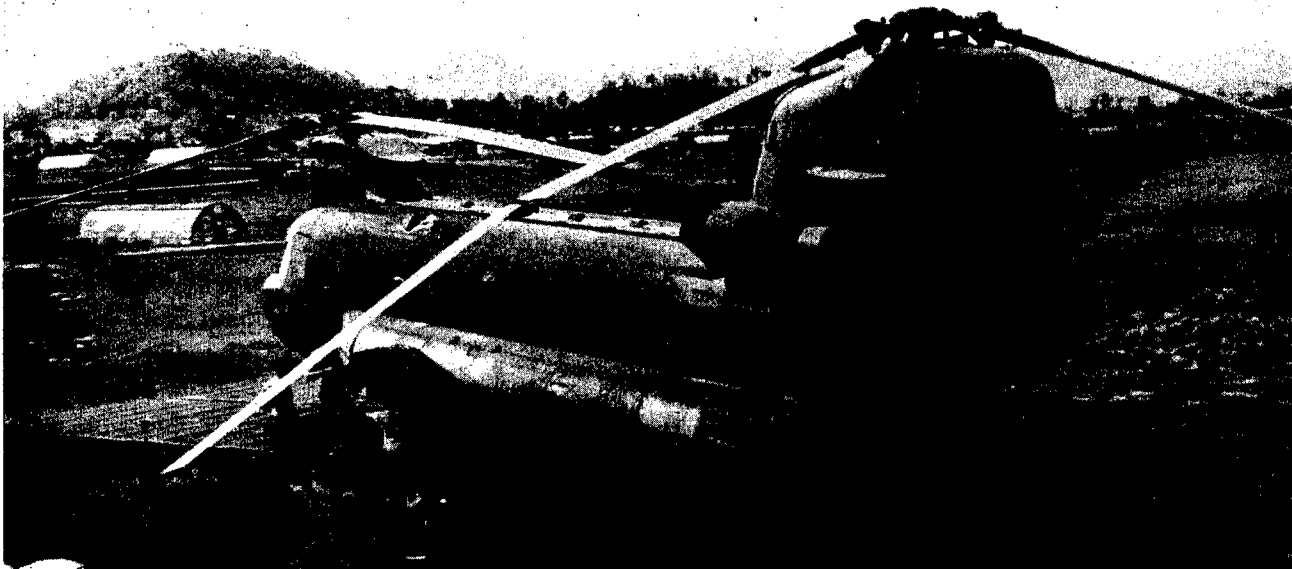
**011506**—Aircraft disintegrated in air. Six crew-

members and three passengers killed. Caused by fatigue failure of spar of one aft rotor blade at station 200.5.

011506-Fatigue failure of aft rotor blade spar caused aircraft to disintegrate during flight.
